HARRY DIAMOND LABS ADELPHI MD  
STRUCTURAL FIRING TESTS OF THE M735 PROXIMITY FUZE.(U)  
MAY 79 J M MILLER, S A BORING  
HDL-TM-79-6

REPORT DOCUMENTATION PAGE		READ INSTRUCTIONS BEFORE COMPLETING FORM
1. REPORT NUMBER HDL-TM-79-6	2. GOVT ACCESSION NO.	3. RECIPIENT'S CATALOG NUMBER
4. TITLE (and Subtitle) Structural Firing Tests of the M735 Proximity Fuze		5. TYPE OF REPORT & PERIOD COVERED Technical Memorandum

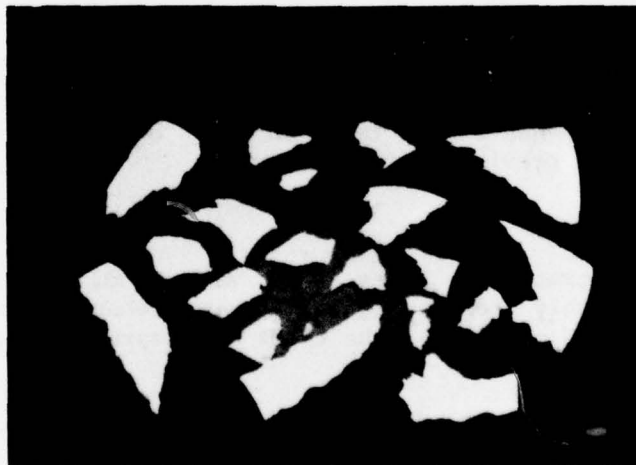
Figure 11. Experimental lightweight cover after firing test.

The second test round also was undamaged. However, the lightweight cover failed at gun firing. A number of small pieces of the cover were recovered at the gun site. Figure 11 shows the remains of the cover. No other fuze component was damaged, and none of the structural parts yielded.

The new compression-molded cover was structurally inadequate. The cover design should be changed back to a laid-up glass cloth of a thinner design. A cover of this type with the reduced wall thickness should provide adequate strength with similar weight savings.

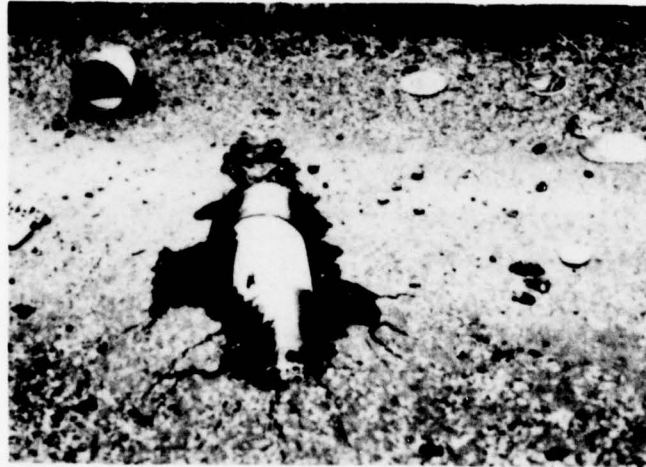
Figure 14. Group 5 structural fuze, hard impact.

Fuze 2 was fired vertically on 21 May 1976. The round went unstable and landed sideways on an asphalt road behind and to the left of the gun. The impact is shown in figure 14. The spoiler plate was never found, but the impression left on the road indicates that it was attached at impact (fig. 15). It was determined that the smaller spoiler plate was ineffective at the higher velocities produced by the gun and charge. Firing was terminated for the day. It was decided that fuzes 1 and 3 be fired down-range on PXR 6165 parachute recovery rounds at YPG.
